Degradation diagnosis of fire-proof material

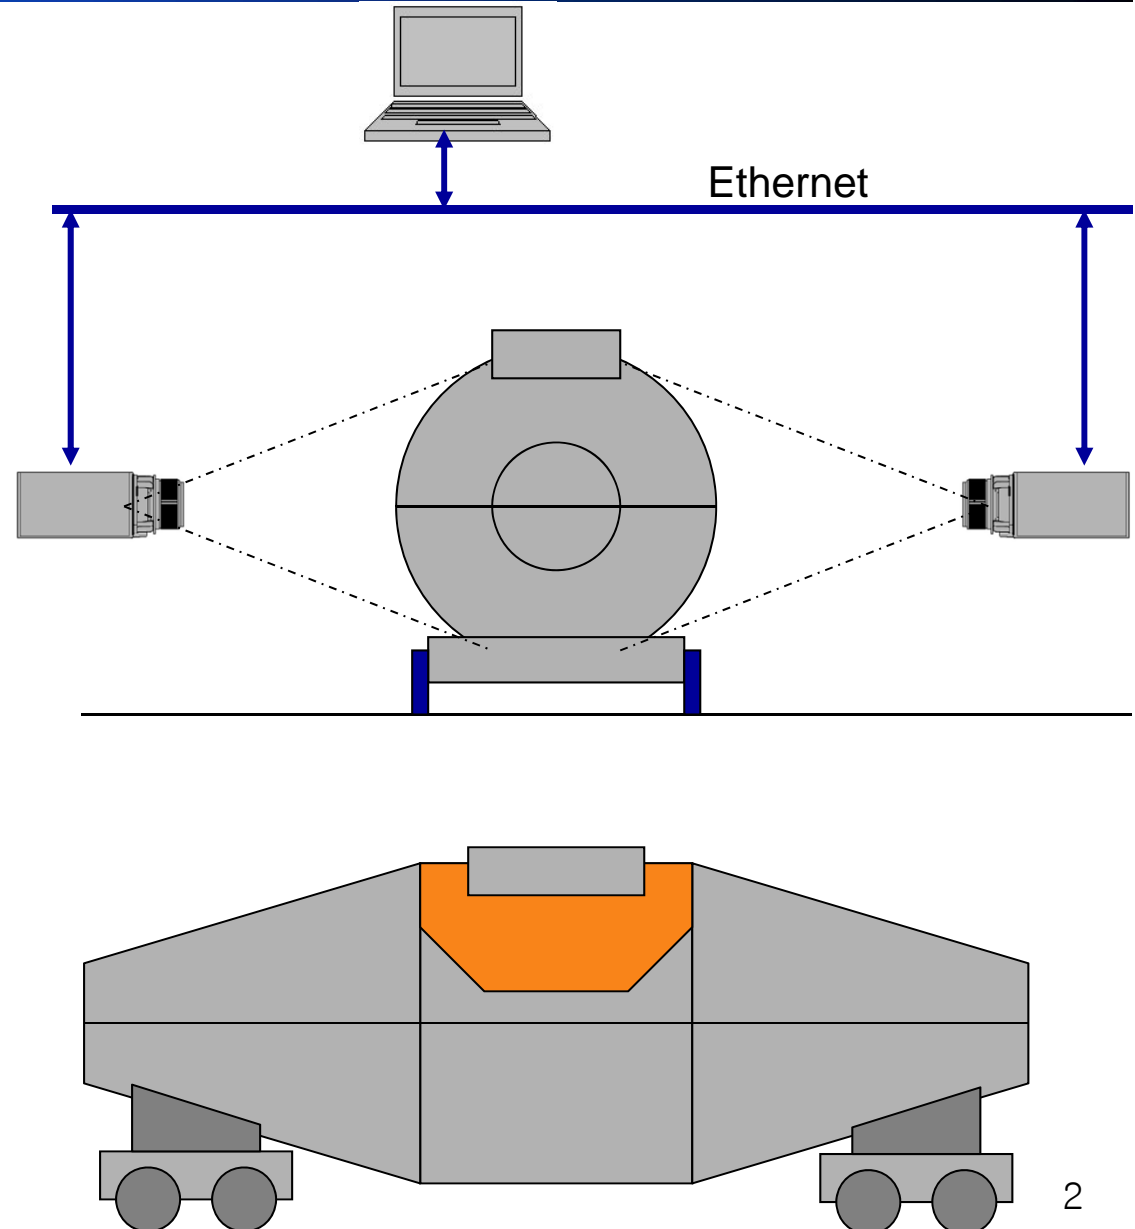
Torpedo car is a container to transport melted iron (pig iron), and its shell is protected by a fire-proof material. Degradation level of this fire-proof material is inspected to conduct appropriate repair.

Temperature distribution of the shell surface is measured using a thermography to understand the degradation level.

If abnormality is found from the surface temperature, detailed inspection of the fire-proof material at the suspected area is conducted.

Because the thermography inspection is conducted during operation, thermal images are taken from the left and the right side of a torpedo car simultaneously, and the captured images are transferred to a computer via Ethernet. The images are stored and history controlled by the computer

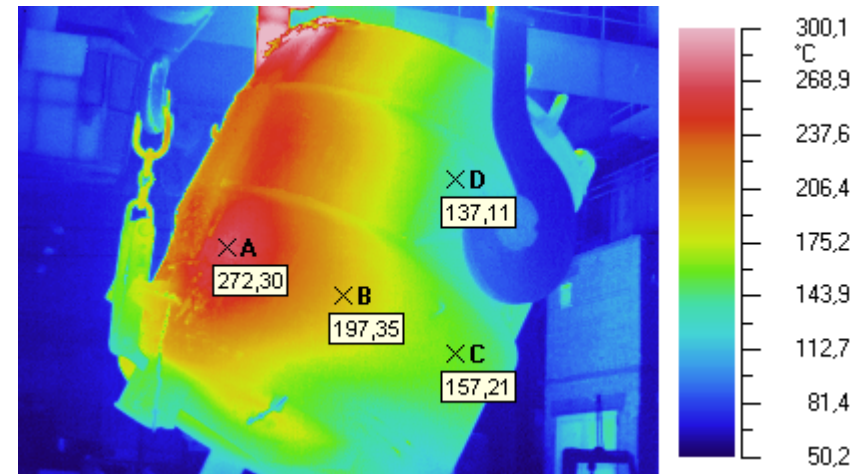
- Ladle is a container for melted iron (pig iron), and its shell is protected by a fire-proof material. Degradation level of this fire-proof material is inspected.

- Temperature distribution on the shell surface is captured by a thermography to understand the state of the fire-proof material.
- If abnormality is found from the surface temperature, detailed inspection of the fire-proof material at the suspected area is conducted.

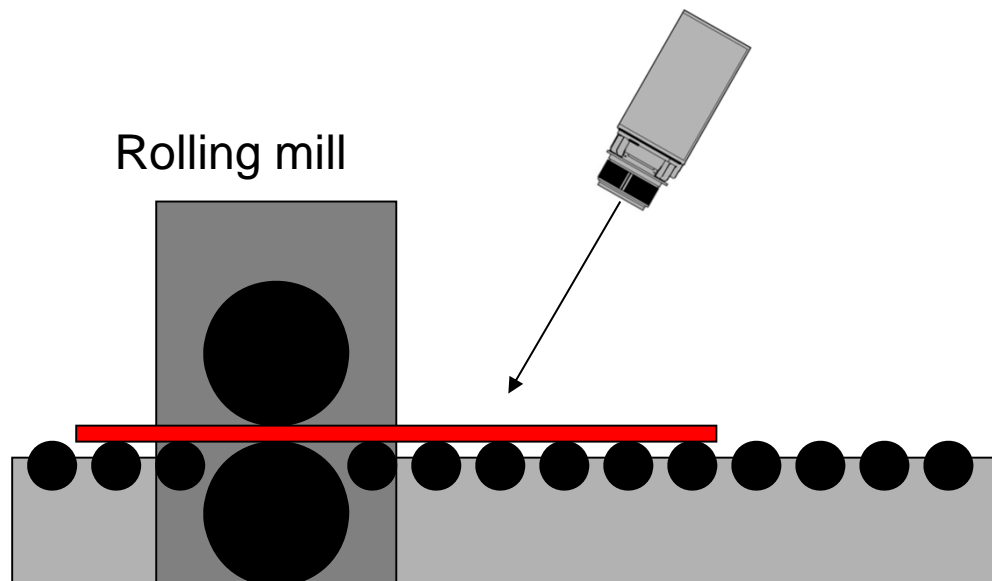
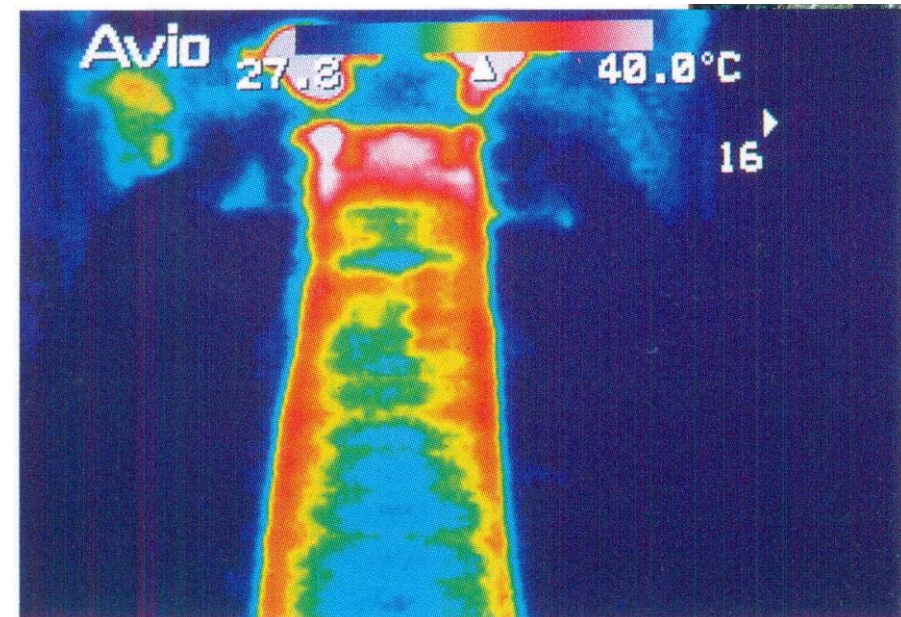
- Background
 - Temperature of rolled plate in the rolling process is controlled.
- Application example
 - Temperature distribution of rolled plate in the rolling process is maintained to be the same in the width direction for stable product quality.
 - Temperature distribution of rolled plates is measured by a thermography, and the result is fed back to the rolling process.

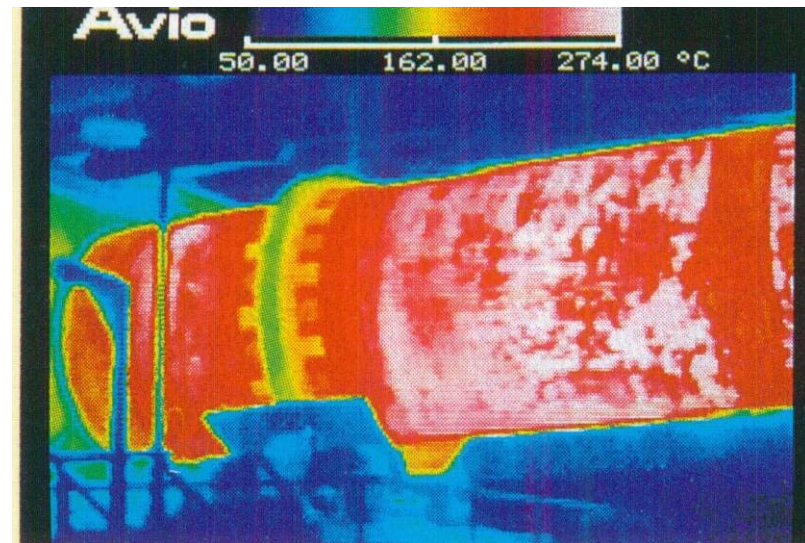
- Rotary kiln is a machine to bake blended raw material for cement.
- Fire-proof bricks are attached on the inner wall of the rotary kiln to protect the shell, and there is a need to understand the degradation level of the fire-proof bricks in the early stage.

- Temperature distribution on the shell surface is measured using a thermography to understand the degradation level of the fire-proof material.
- If abnormality is found from the surface temperature, detailed inspection of the fire-proof material at the suspected area is conducted.

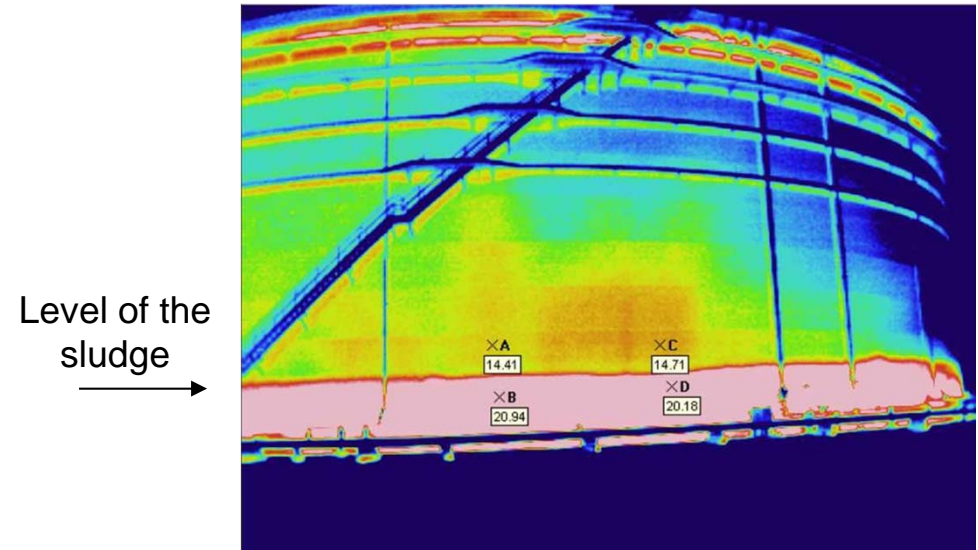
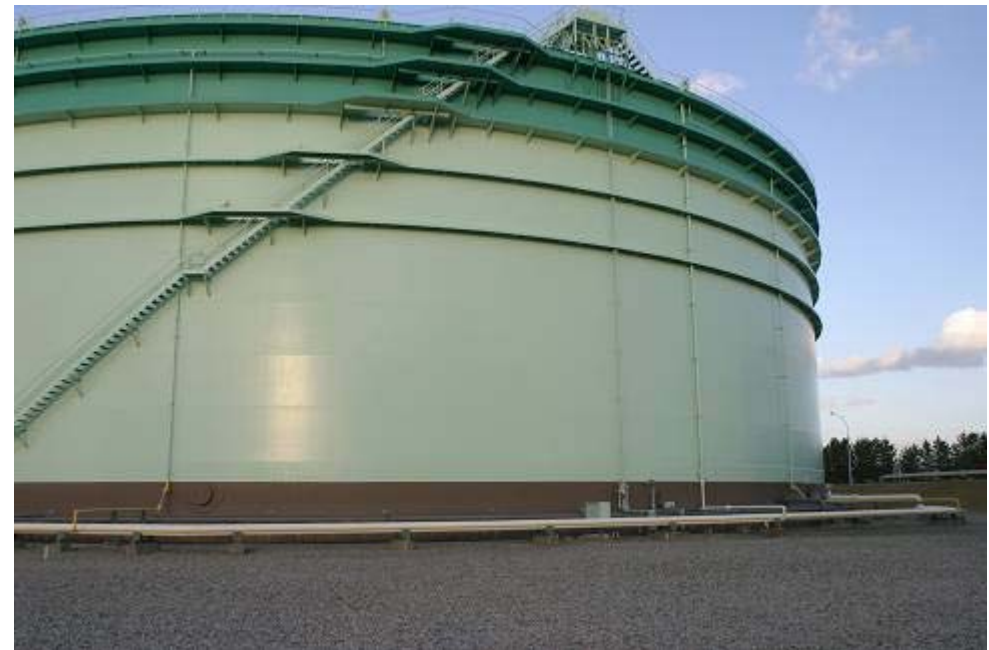
- The amount of sludge in oil tanks is measured.

- Because the side wall of an oil tank is very thin comparing to the amount of oil inside and its thermal conductivity is good, the surface temperature of a tank is almost identical to the temperature of oil or sludge inside.
- If there is a temperature difference because of the sludge accumulated in the bottom of a tank, the height of sludge will appear on a thermography, and the amount of sludge can be estimated.

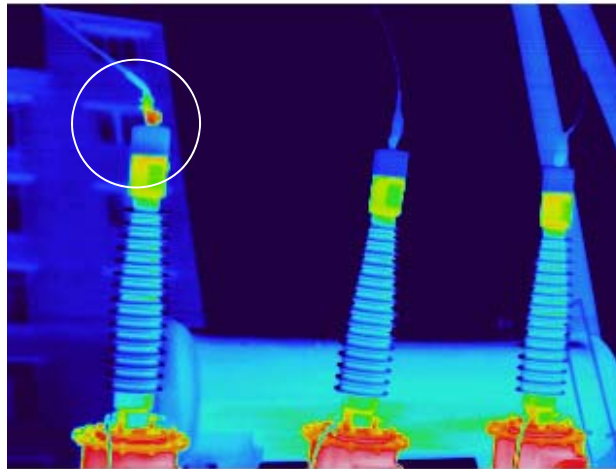
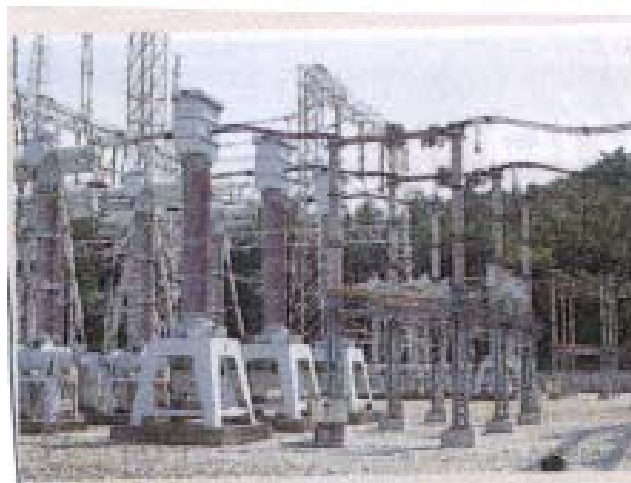
Abnormal overheating at a transformer facility

- When electric current flows through a resistor, a heat will be generated.
- Abnormal heat is an evidence for excessive load-current or excessive resistance.
- If the load condition can be somehow verified, the reason can be identified.

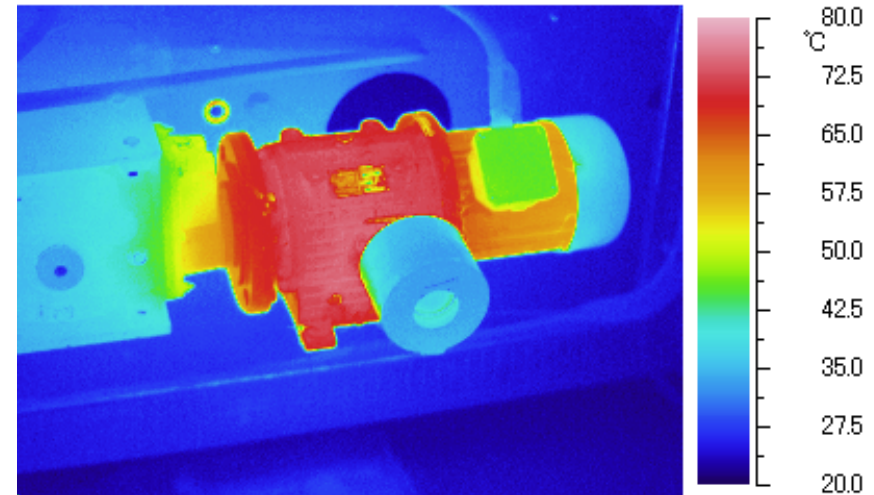
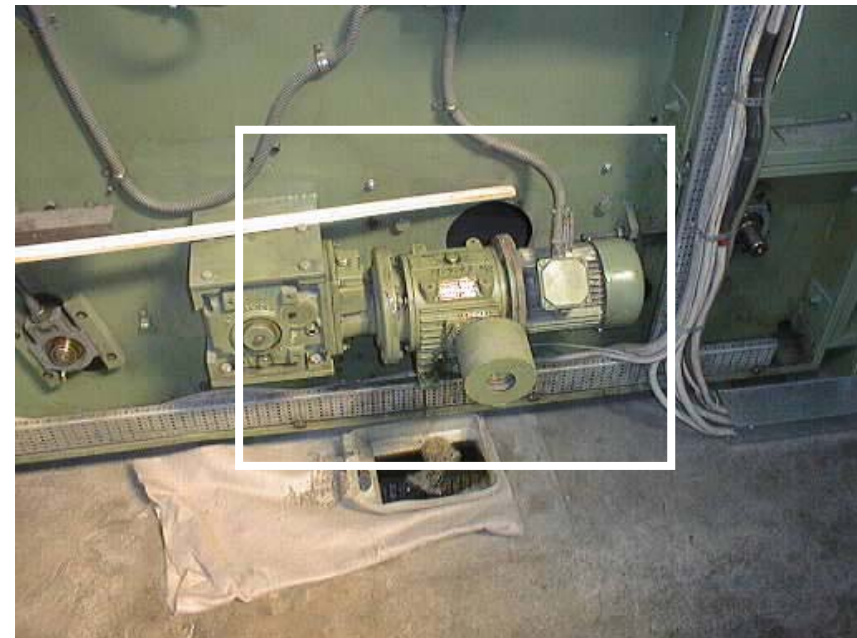
- Understand the state of a motor power facility.

- Excessive load to a motor will result in heat generation.
- If there is an overload to the motor, naturally there will be a heat generation. There will also be a heat generation if there is a defect in the motor or if there is a defect in the transmission mechanism which takes out the load (such as the bearing).
- If the load status can be understood by some means, the reason for the heat generation at the motor can be identified.

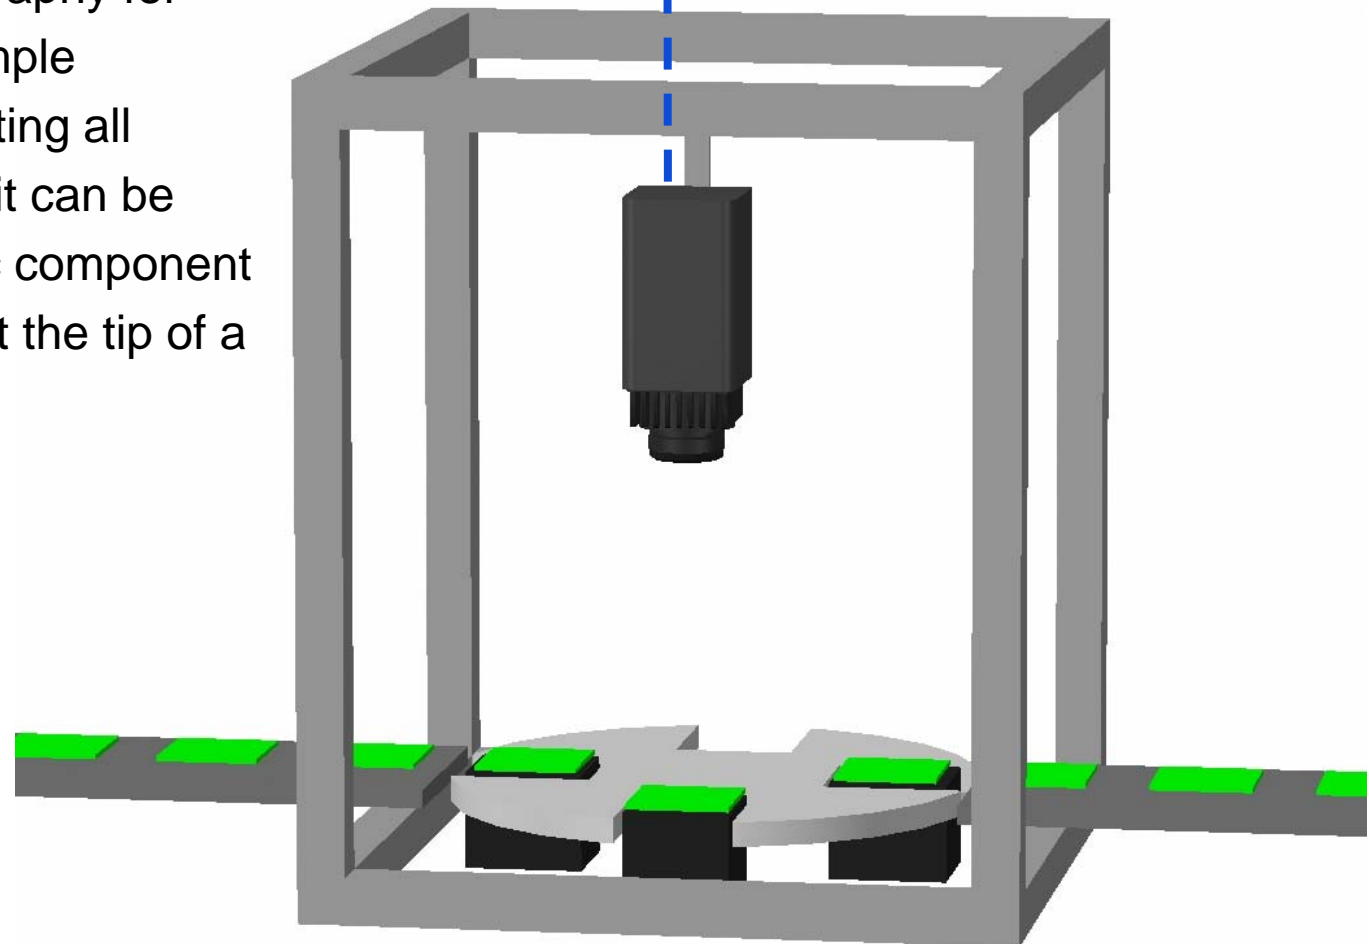
Because it is a thermography for monitoring control of simple configuration by eliminating all unnecessary functions, it can be installed in an electronic component inspection machine or at the tip of a robot arm.

RS-232C, IEEE1394, Ethernet,
video signal, alarm contact signal,
remote control signal

Images can be transferred at the rate of 60 frames per second using IEEE1394.

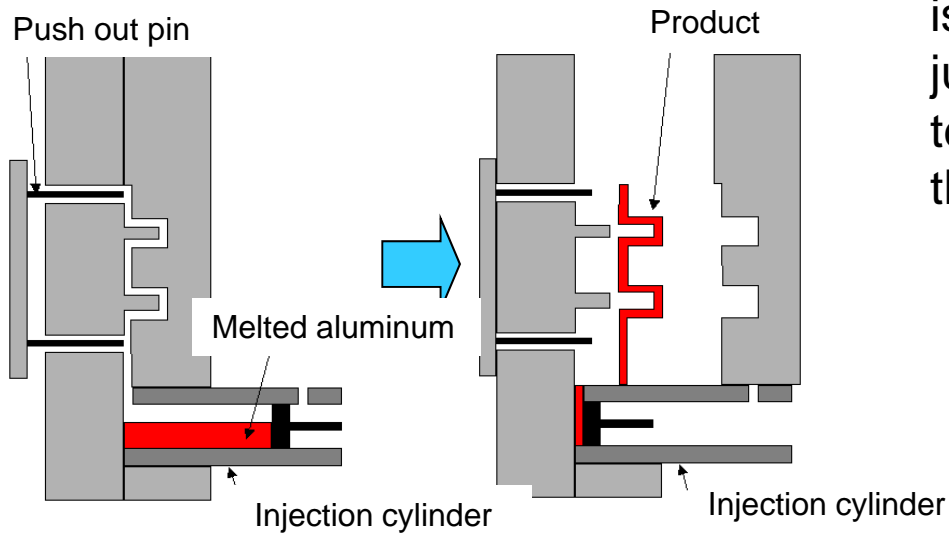
- Temperature control of die casting metal mold

For improved product quality and longer life of the metal mold

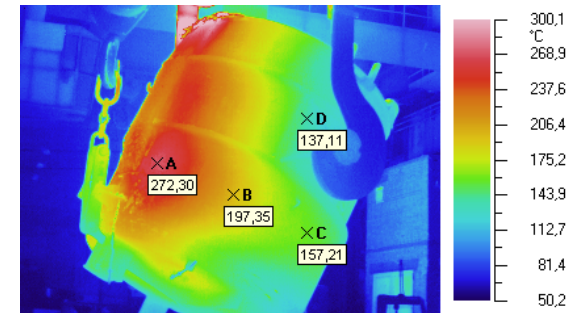
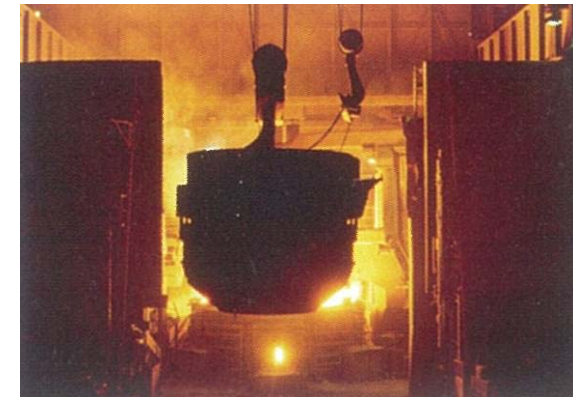
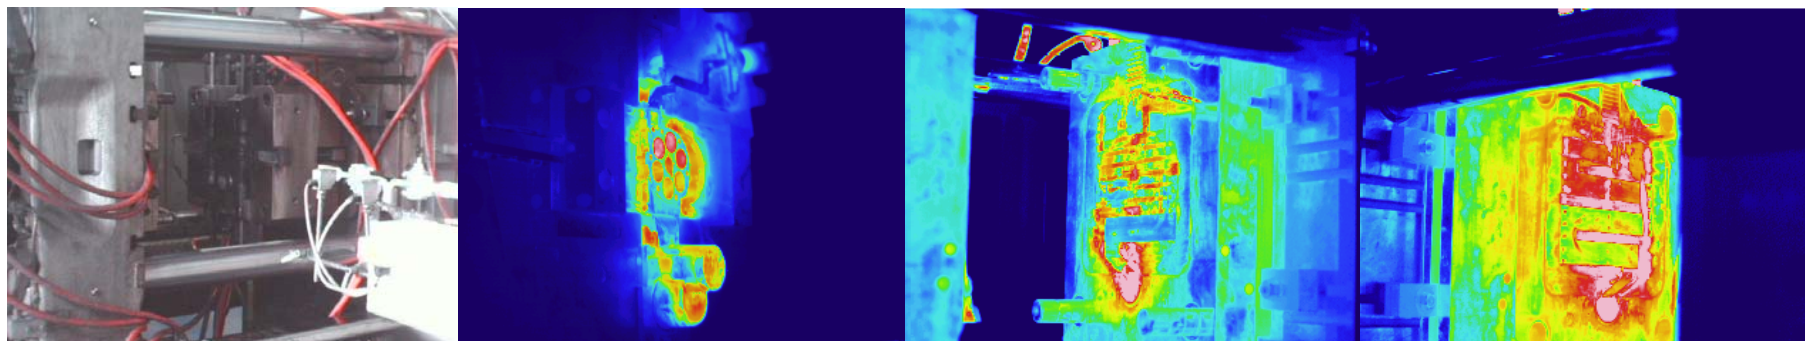
- Monitoring for degraded fireproof roof material of a ladle

Degradation of fireproof material is monitored and judged by the temperature of the shell.

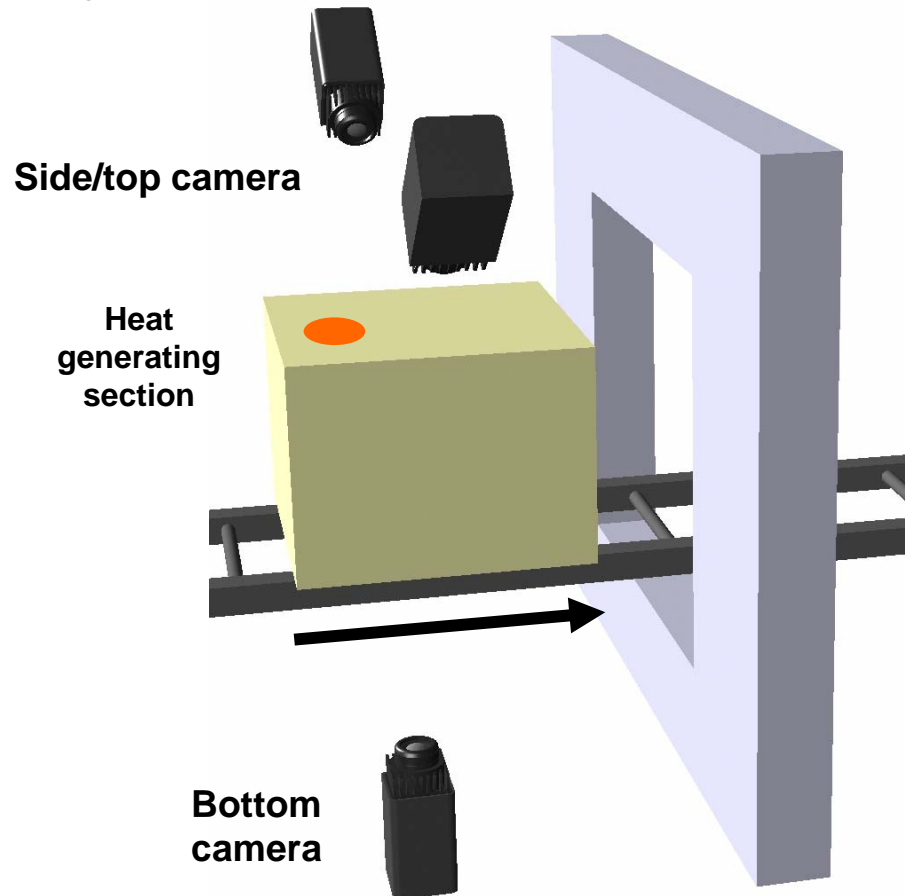
Automated warehouse

- Goods are measured by three monitoring control thermographies before entering the automated warehouse.
- Alarm is sent out when the temperature of the goods exceeds the preset temperature.

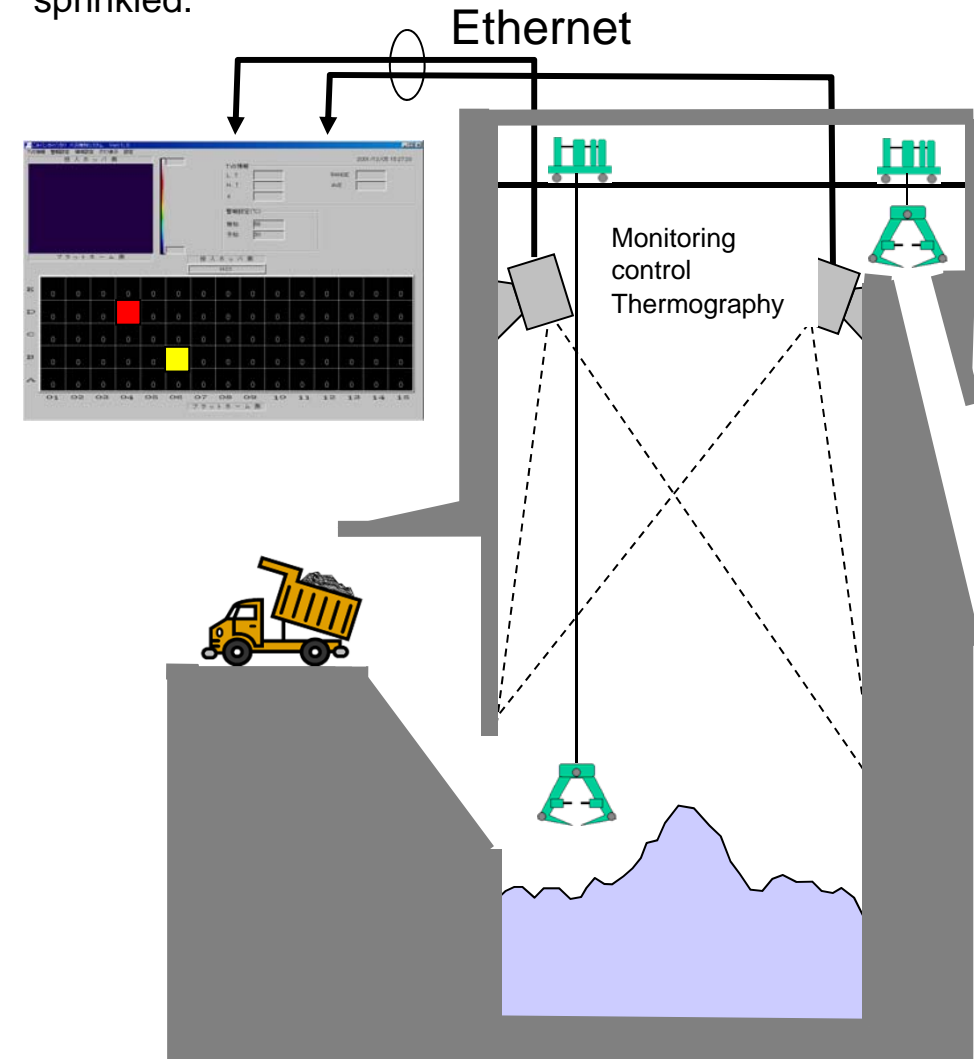
Garbage pit

- Natural fire on garbage is detected, and water is sprinkled.
