Flu Control at a Preschool

~ Hoshino Hikari Preschool ~

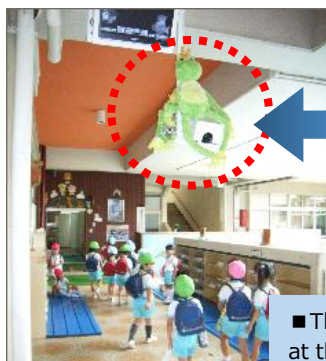
■ Thermography installed at the entrance (Froggy)

Thermography is installed in a position where toddlers must pass everyday. It automatically measure body surface temperature when toddlers say hello to the froggy on top of it.

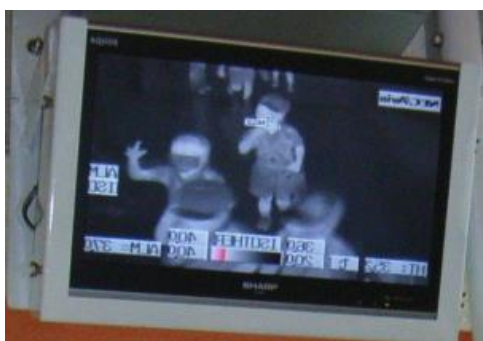
Heated area over 37°C is displayed in **red color**. Alarm sound is generated simultaneously.

When a fever is recognized.
(Image)

Thermal image is displayed to monitors at administration office and health room, where teachers check. When a toddler is found over 37.0°C, alarm sound is generated so that teachers can identify and take care of them.
